## SUSTAINABLE DEVELOPMENT IN COMMUNITIES AFFECTED BY FLOODS

**Abstract:** The present study pursuits to analyse the impact of the 2005 floods from the Timiș district in relation with the concept of sustainable development. In the first part of the study it's presented the finalization process of the concept of sustainable development, being followed by the presentation of the effects of flooding and some conclusions.

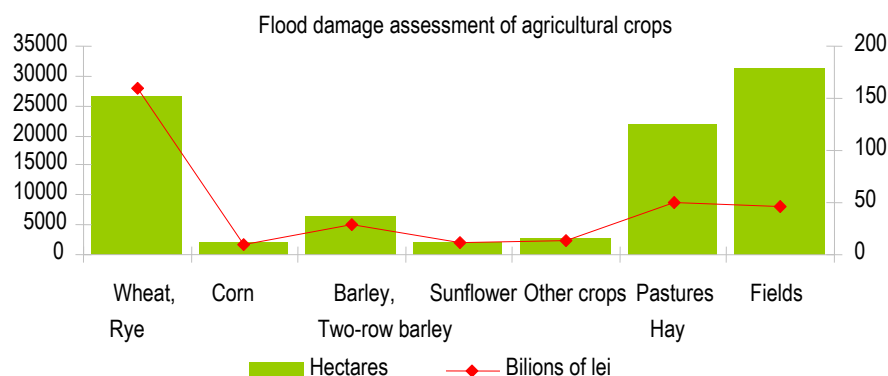
The floods caused significant damages. From the data of the Timiș County Inspectorate for Emergency Situations results that a total area of 92.456 ha was flooded, from which 39.432 ha were crops, 21.744 ha pastures, hay and 31.280 ha other agricultural land.

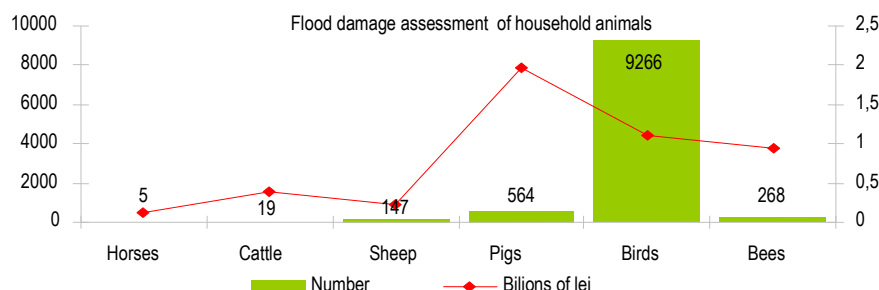
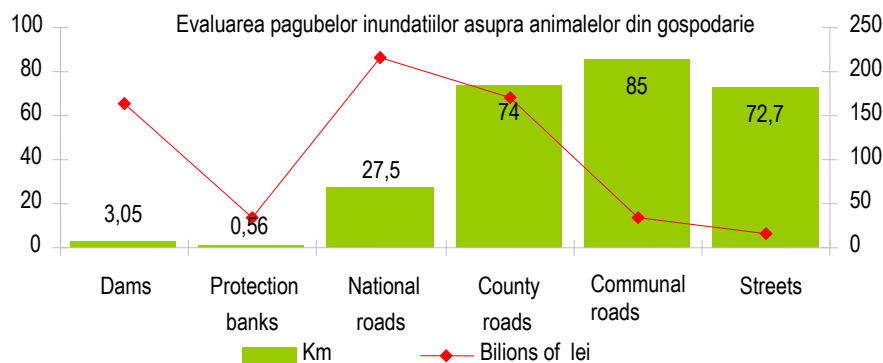
In the Infrastructure Domain the following effects have been reported: 96 damaged footbridges, 47 damaged bridges, 31 flooded communal streets, 40 km

of damaged National Roads and 22 km flooded, 70 km of damaged County roads and 20 km flooded, 81 km of damaged communal roads, and 8,7 km of flood damaged rail road and 12 km flooded.

From the data provided by SC Electrica SA, Timișoara Branch, these damages appeared : 994 damaged electrical connections following the collapse of the flooded houses, 33 flooded transformers etc.

Those losses are added to the deterioration of dams : 400 m on the Bârzava river at Gătaia, 300 m on the Timiș river at Giulvăz, 400 m on the Timiș river at Foieni, 250 m on the Timiș river at Găvojdia, 100 m on the Bârzava river at Birda, 750 m on the Timiș river at Lugoj, 1.650 m on the pe Bega river at Margina, 100 m on the Timiș river at Ciacova. There were damaged 5 pumping stations at Giulvăz, Foieni, Banloc and Uivar and 2 non-permanent accumulation at Brestovăț.
